Petition – Save this beautiful ash tree from being felled by Coventry City Council

**Executive summary:**

**Date 29 August 2023**

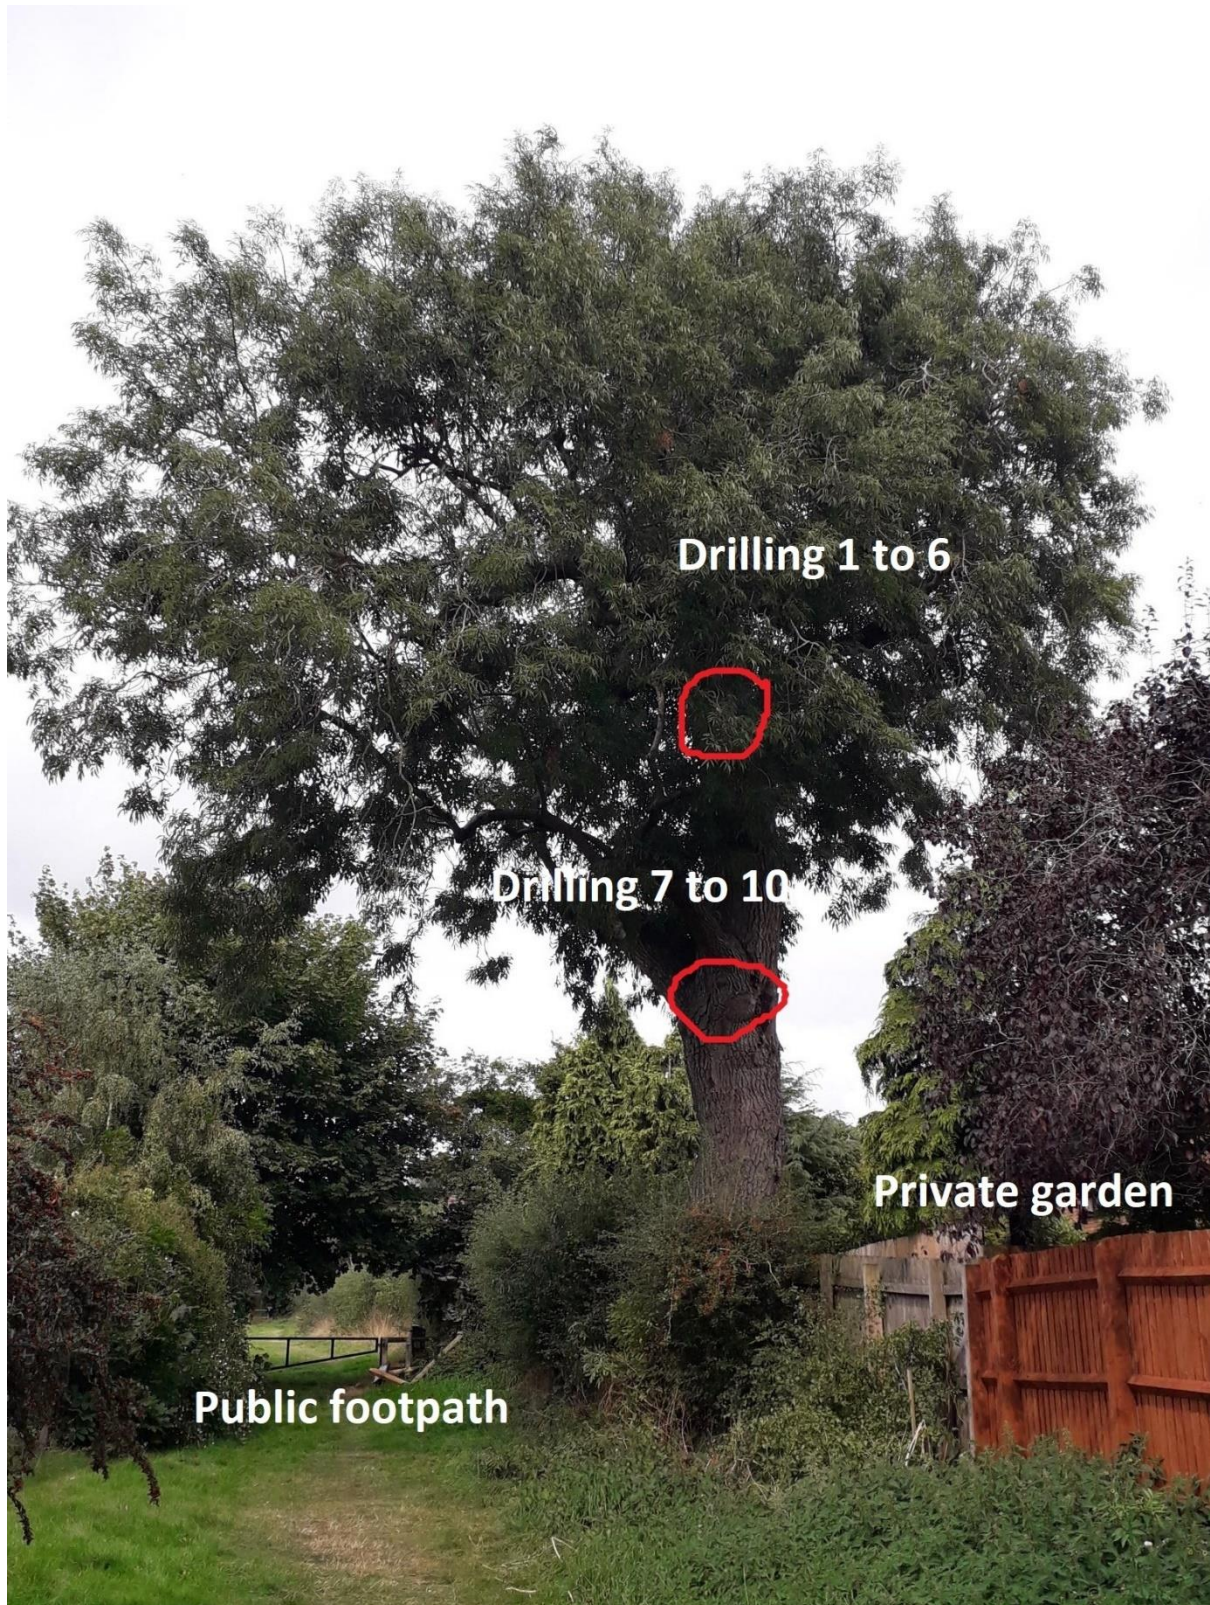
- 1.5 The conclusion after the visual assessment was that it is now time to remove the tree and make the area completely safe. The tree was and is displaying fungal fruiting bodies of the wood decay pathogen, *Inonotus hispidus*. This disease is significant on Ash species trees due to the way in which it effects the structure of the wood tissue. It makes the wood brittle and easy to snap. This leaves the tree vulnerable to major failure in moderate weather condition or periods of drought.

Photo 1. Tree position and areas of concern.

- 1.6 Works were ordered to fell the tree to leave a standing trunk at approx. 4m tall which, will form valuable habitat for invertebrates whilst making it safe for those that pass by or live adjacent to it. When felling trees, we normally write to all nearby residents to inform them of the works and how the landscape will be affected but, due to the quantity of works being raised at the beginning of the financial year, this task was overlooked and no letters were sent out. When the contractor arrived to undertake the works, a nearby resident complained that no one knew of the works and quite rightly, pointed out that it was bird nesting season. We halted the job and tried to discuss the matter with the local resident. Soon afterwards a petition was raised to stop the tree from being felled. The petition gained 151 signatures.

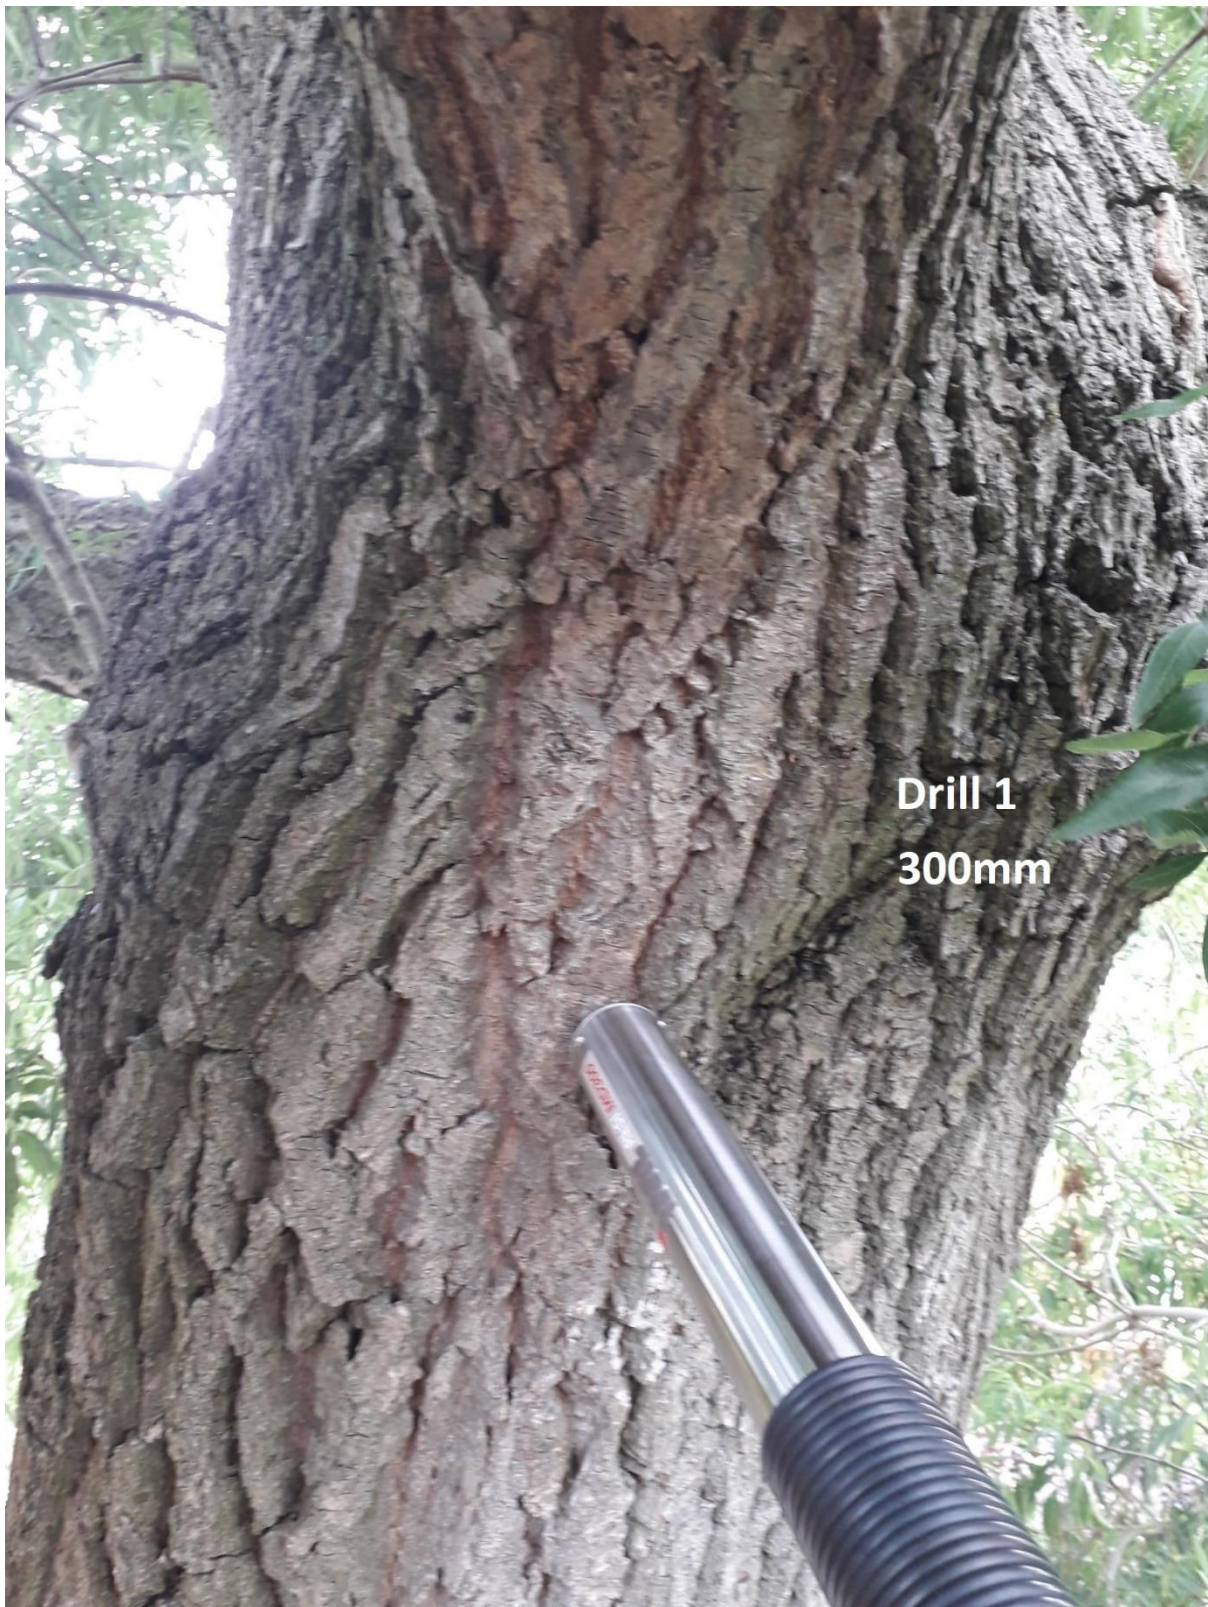
Photo 2 – drilling 1

- 1.9 The initial concern for the trees structure is now confirmed by the drilling. Some of the points of drilling in the upper part of concern, have only 10 or 30mms of healthy wood tissue present and with the diameter of the trunk at this level being 525mm, we would need to see approx. 175mm of healthy wood to be able to be happy with its condition. This confirms that a future major failure is likely. Just when this will be, is not easy to estimate but, this tree is outside the known acceptable parameters of tree management in relation to wood decay and should be made safe. The HMSO publication – Research for Amenity Trees, “The Body Language of Trees” outlines the appropriate management of trees with decay and is the reference in situations like this.

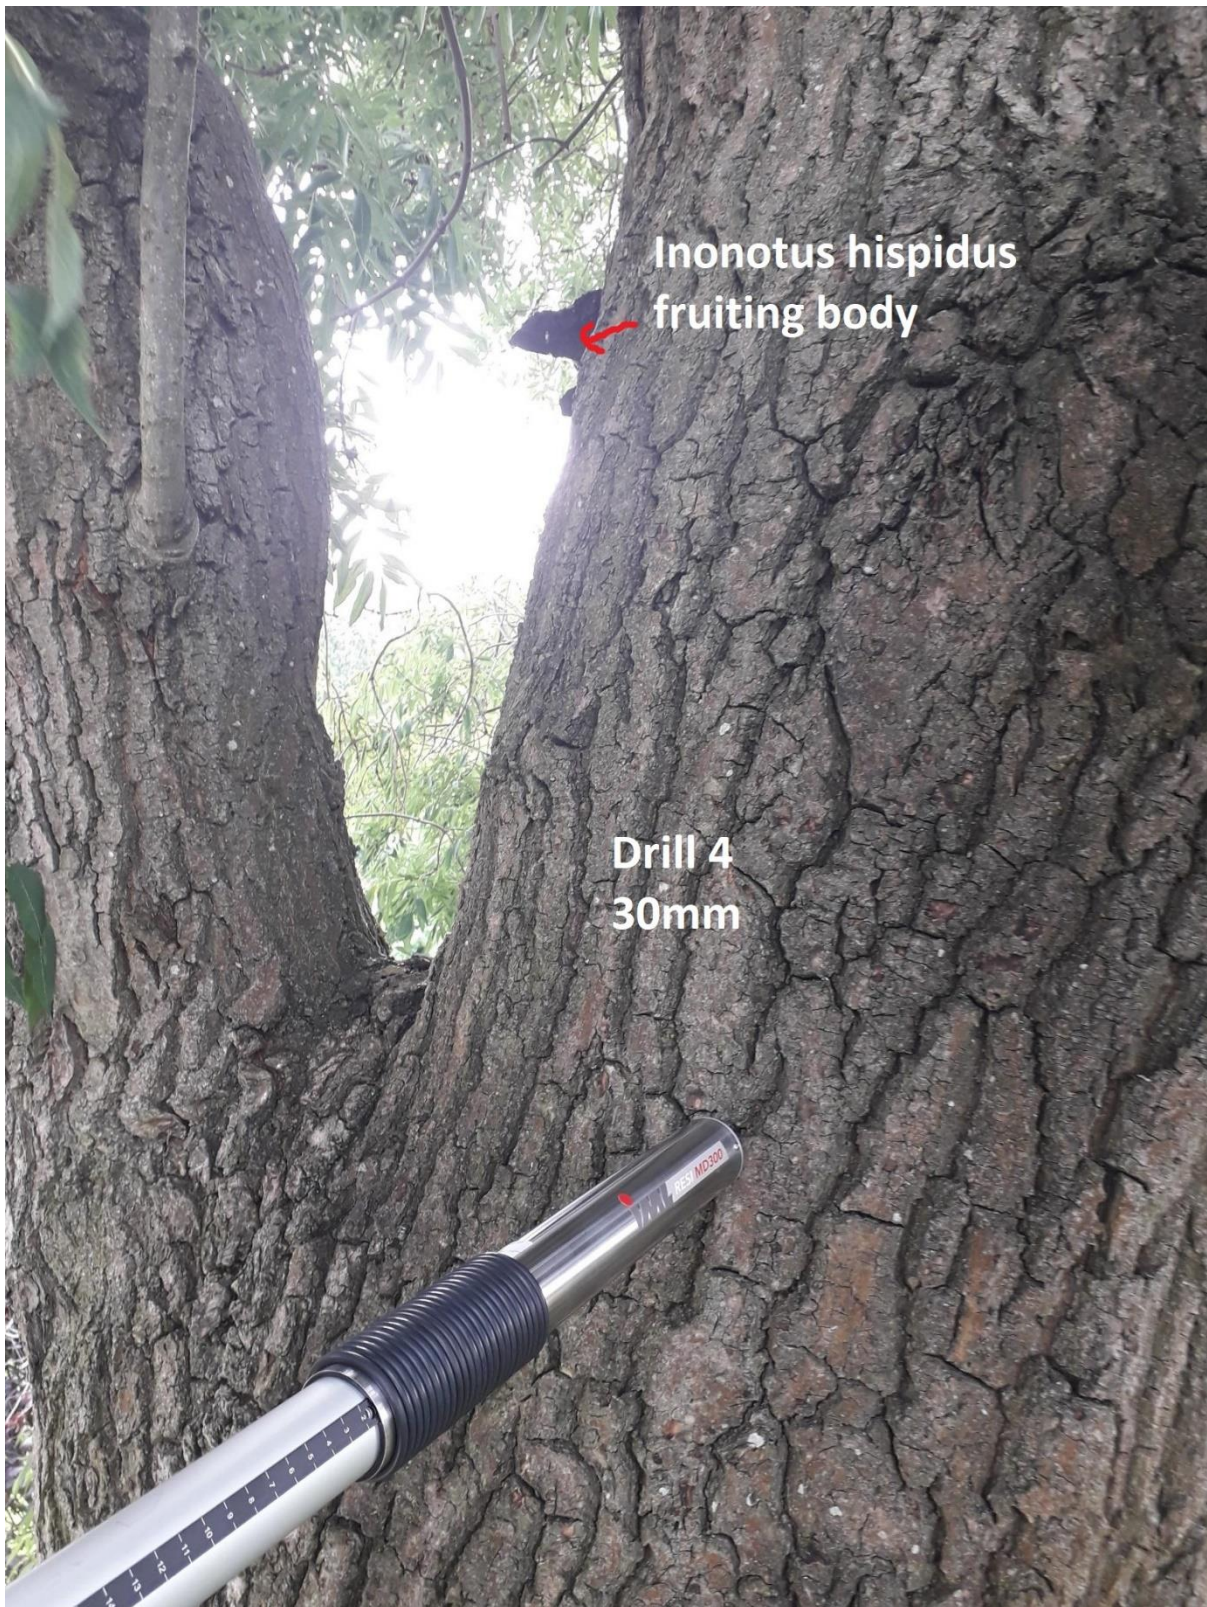
Photo 4 – drilling 4 and noting fruiting body above.

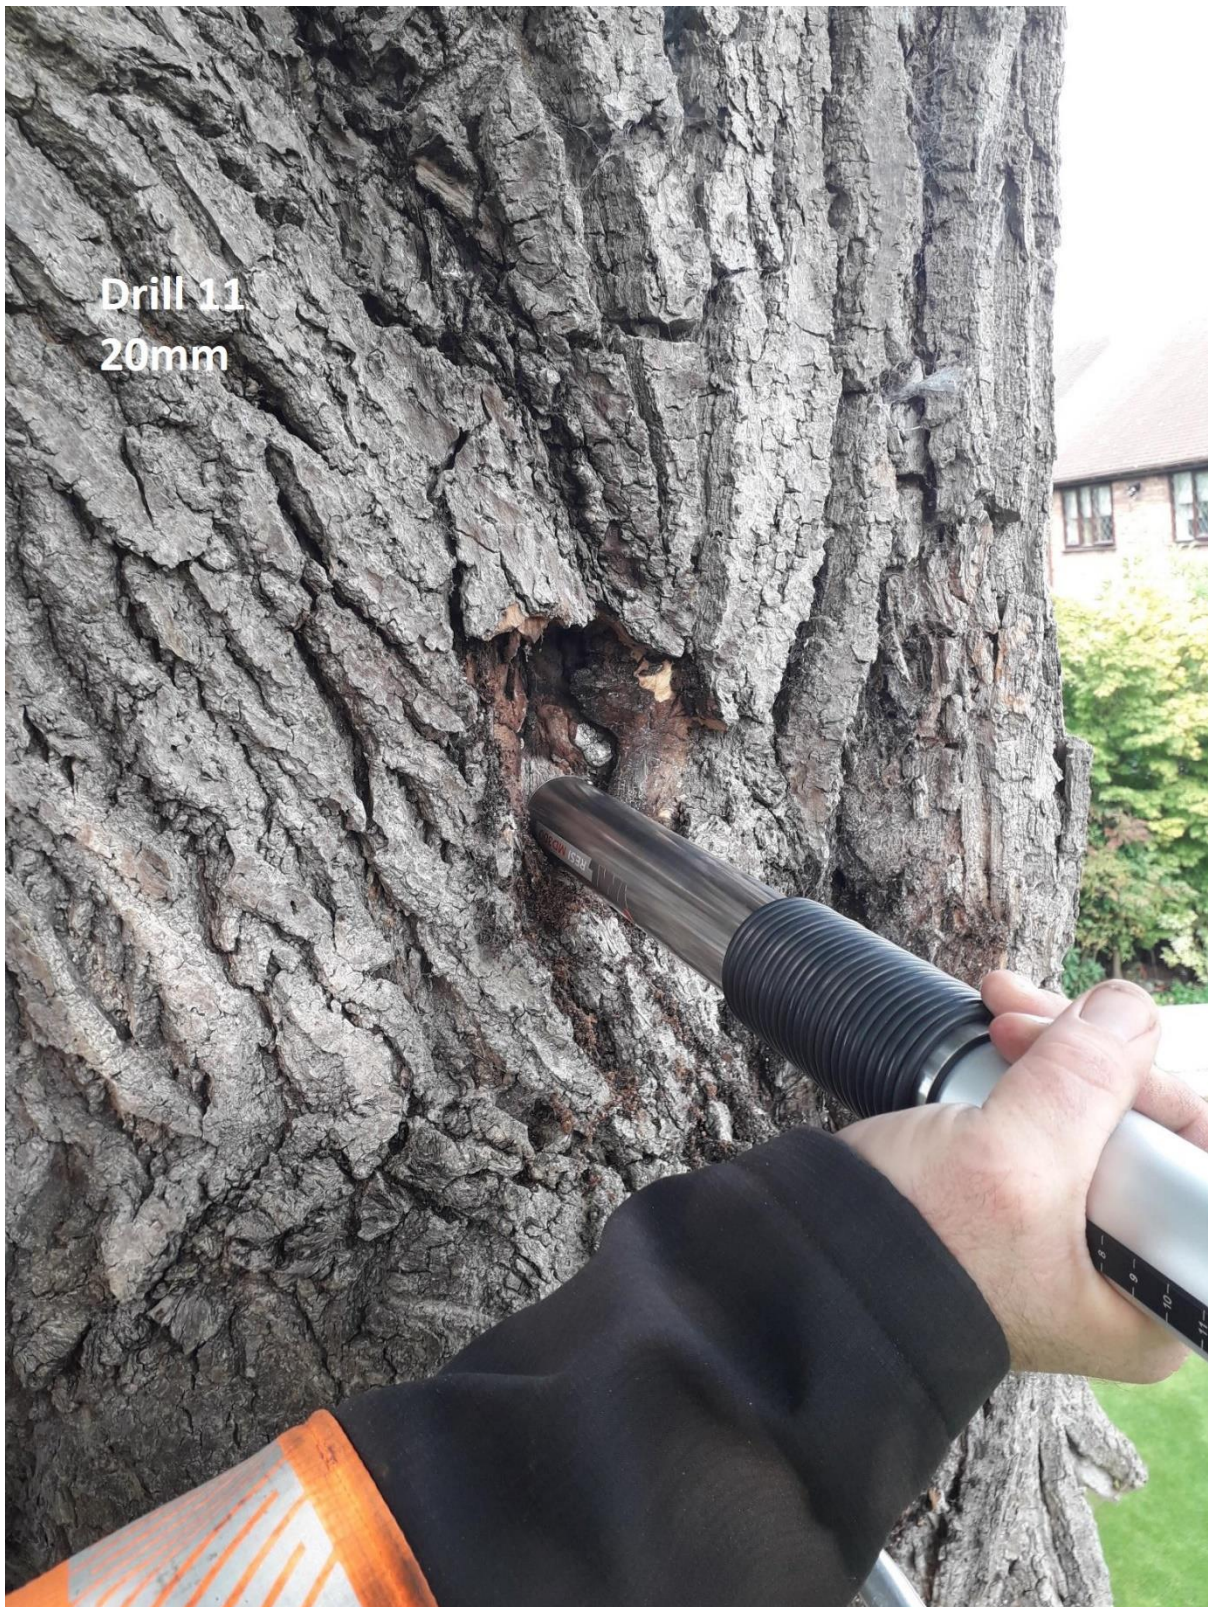
Photo 11 – drilling 11. Small area of bark killing.

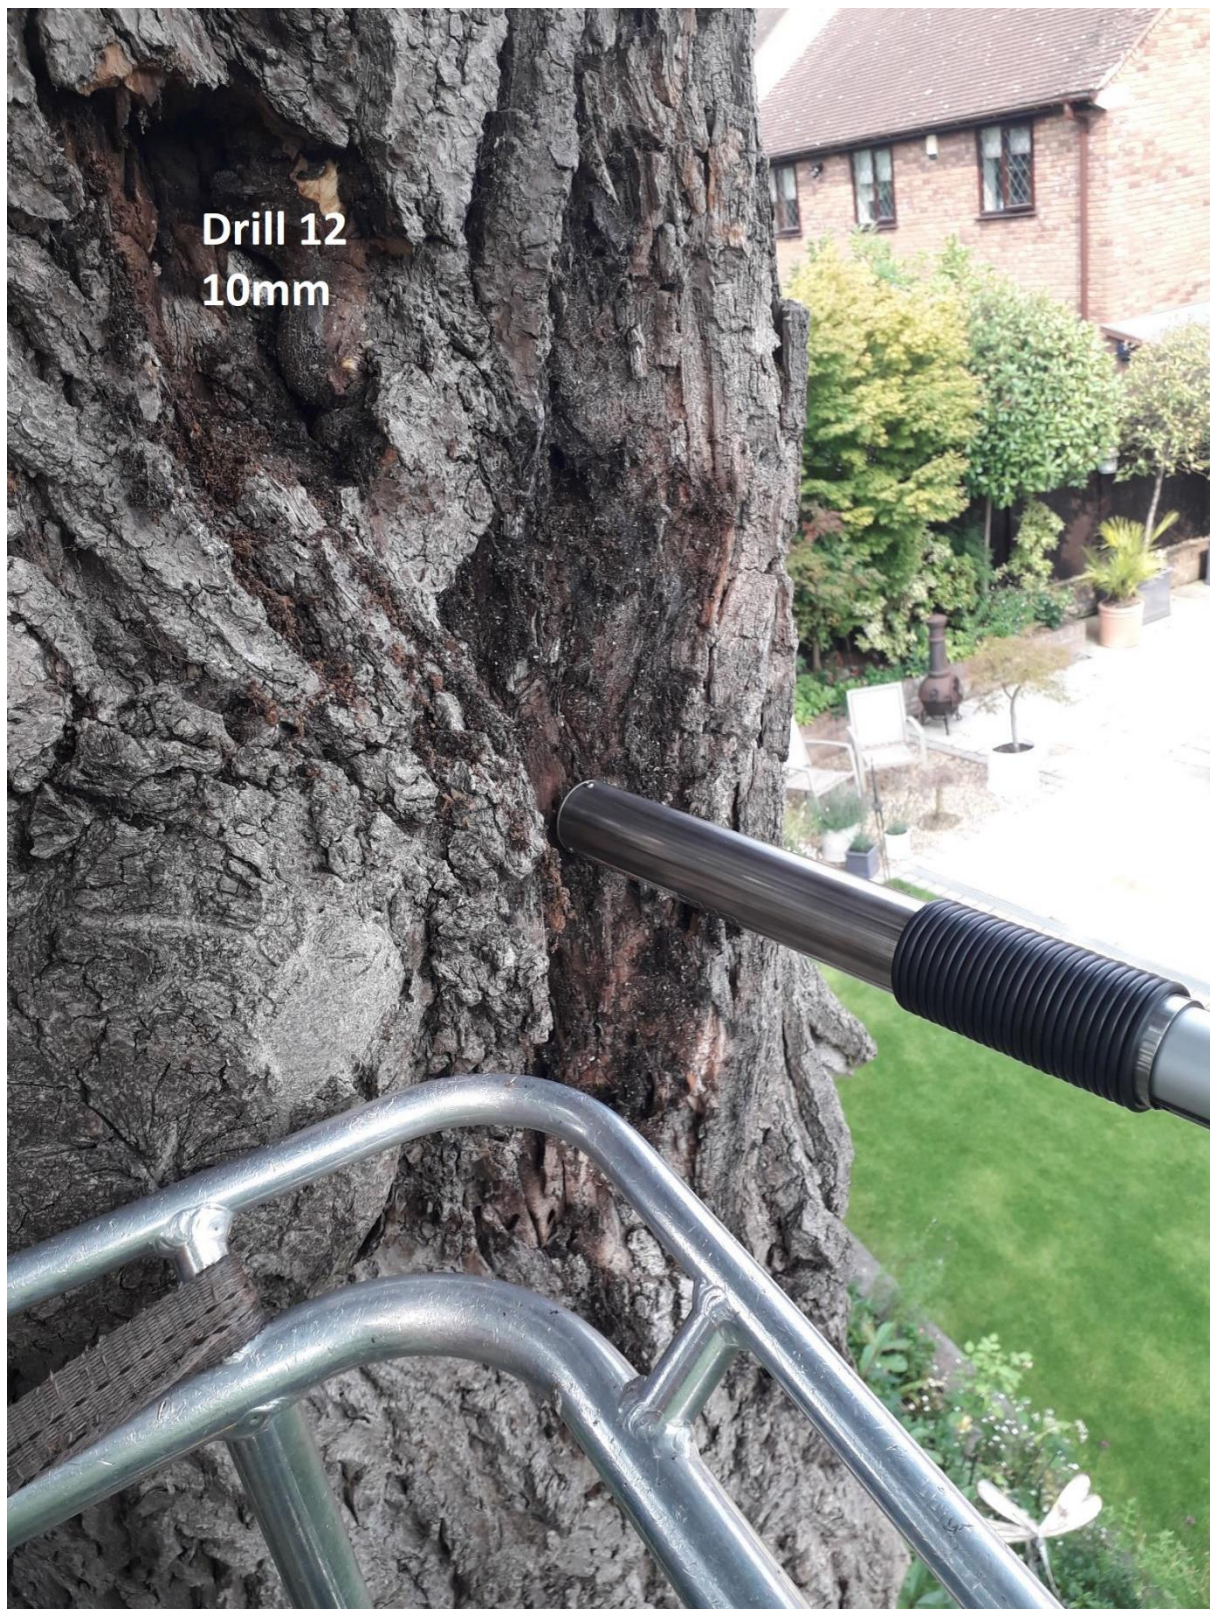
Photo 12 – drilling 12. Large area of bark killing and thin layer of new wood.

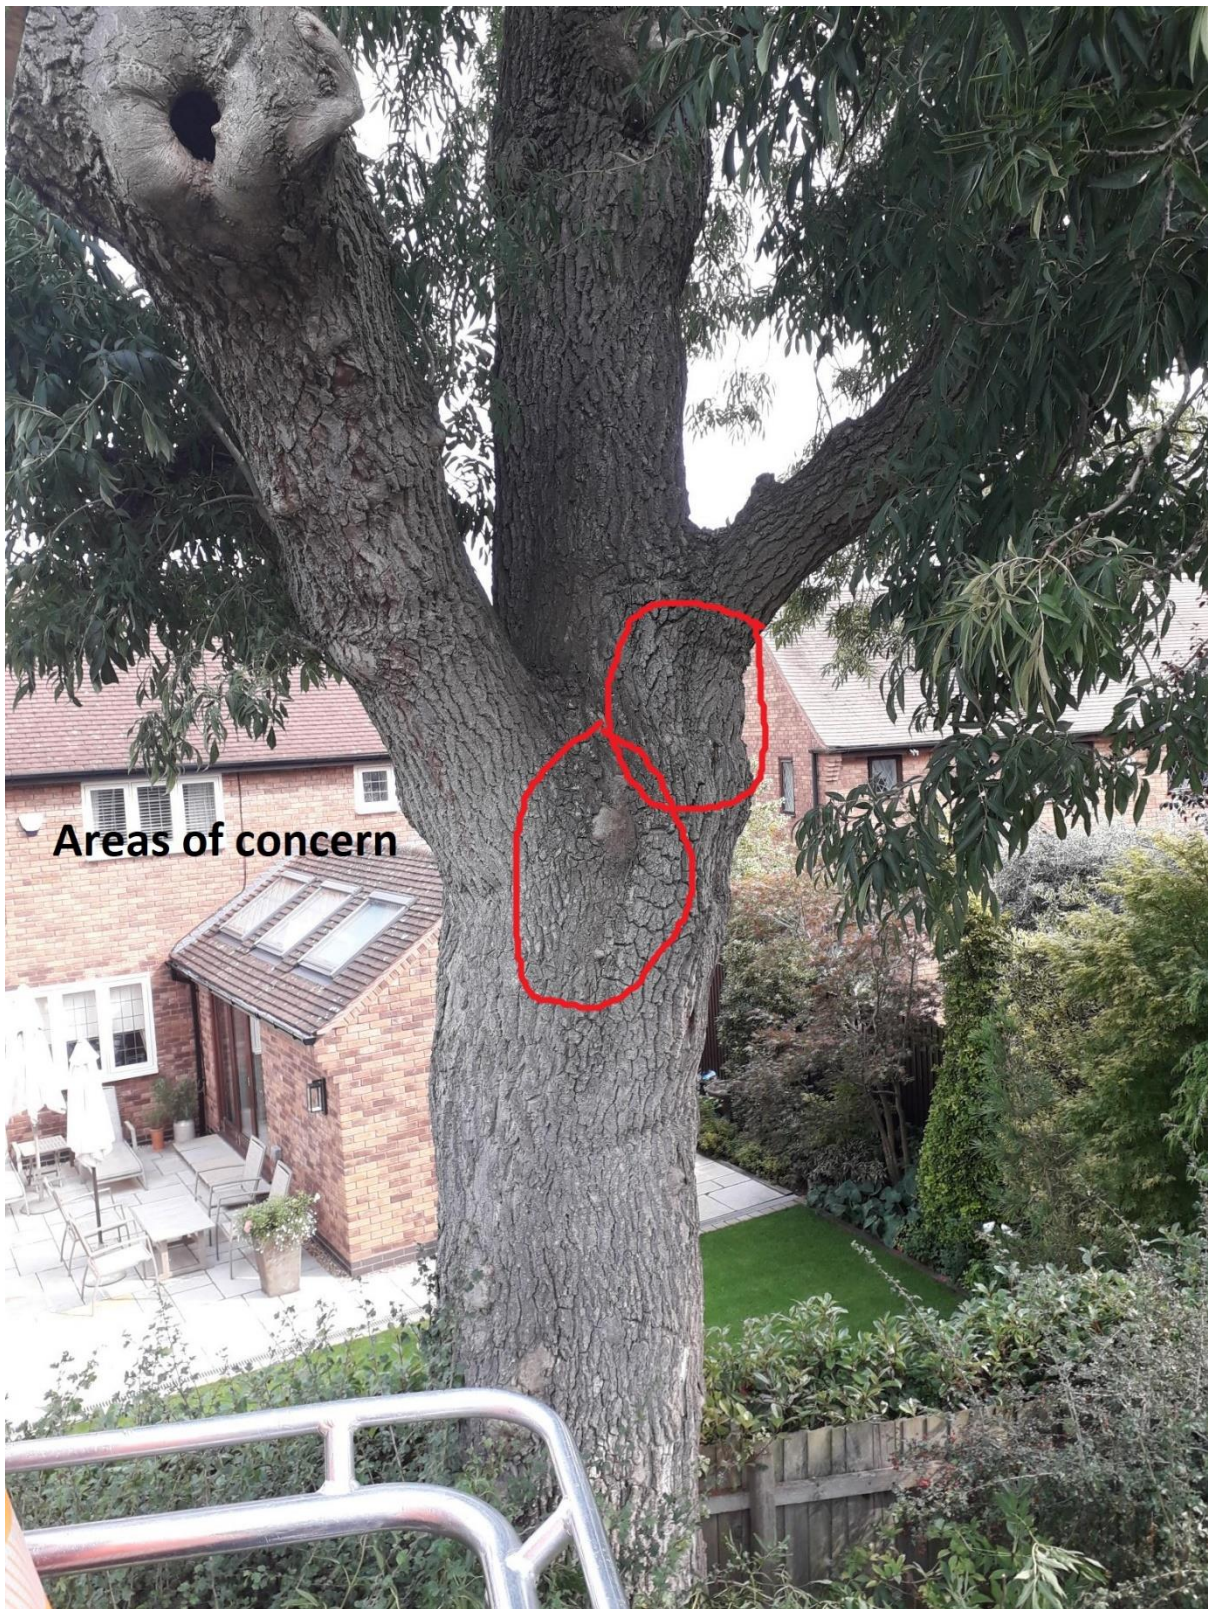
Photo 13 – areas of concern. Mid trunk. Drilling 7 to 10.

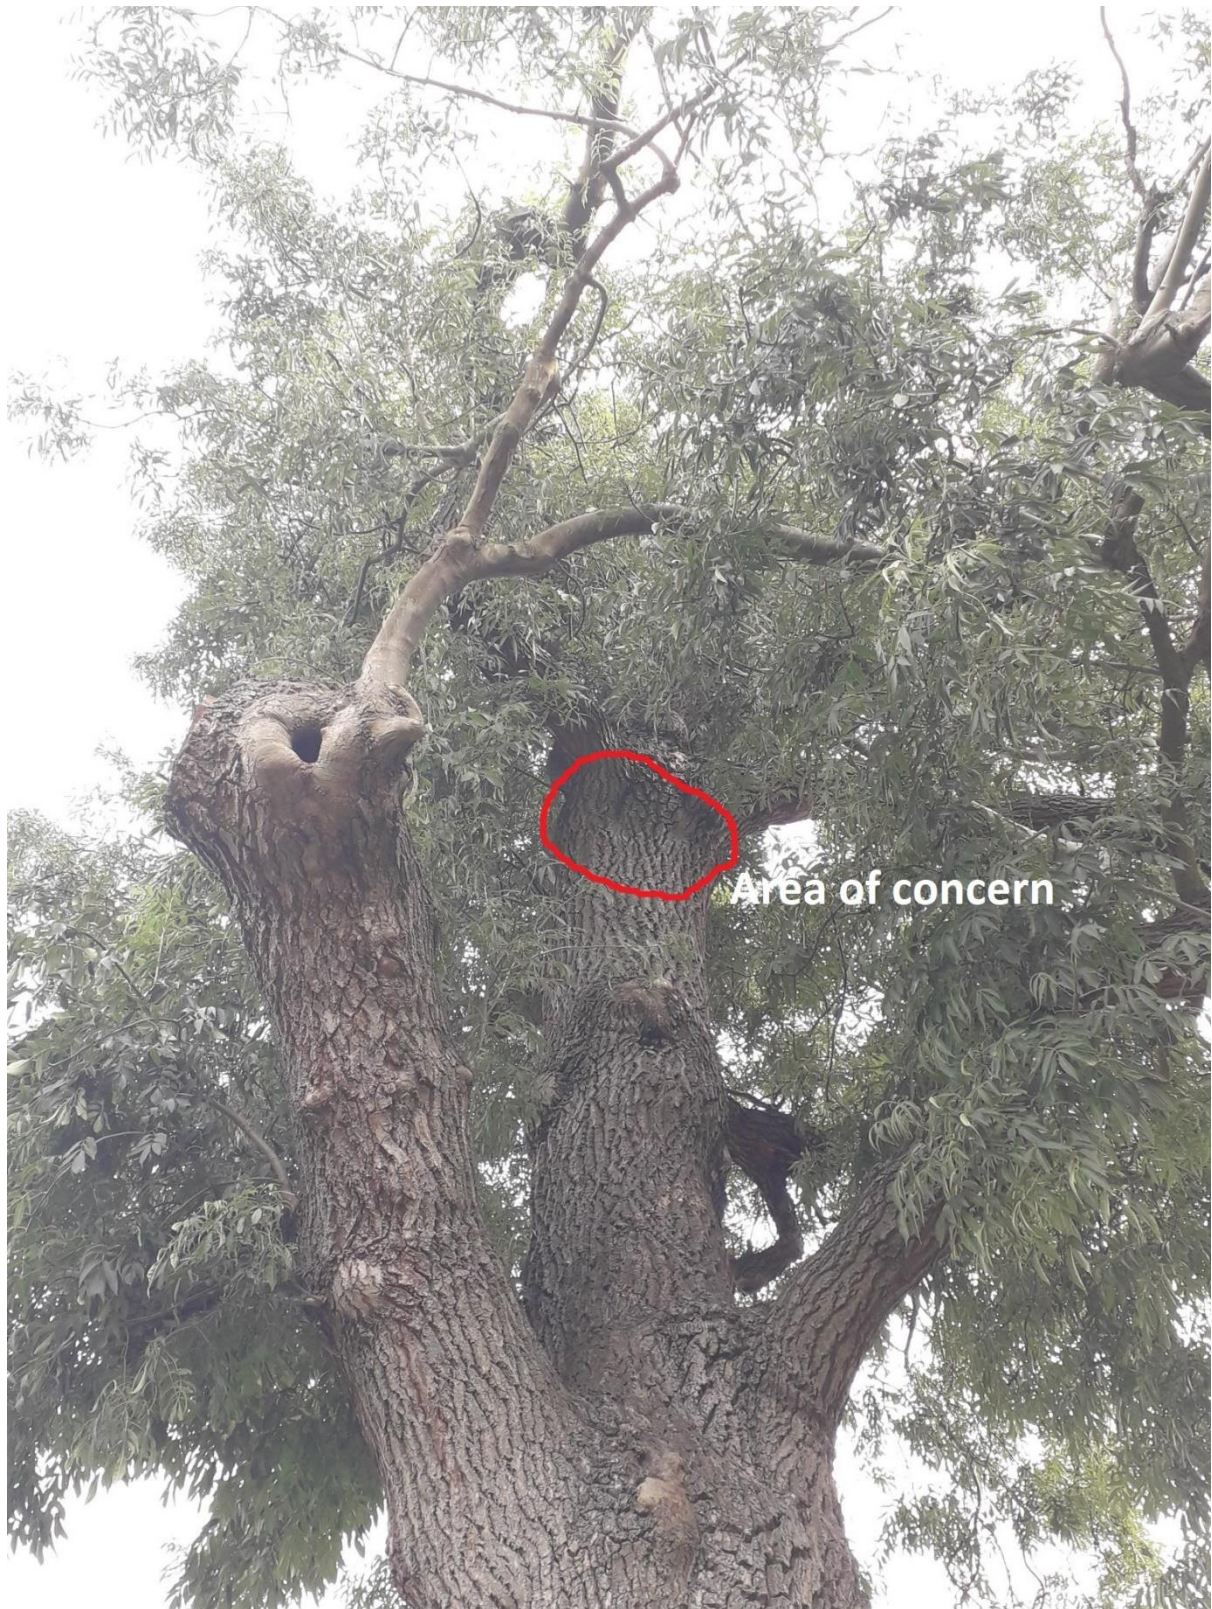
Photo 14 – areas of concern. Upper trunk. Drilling 1 to 6.

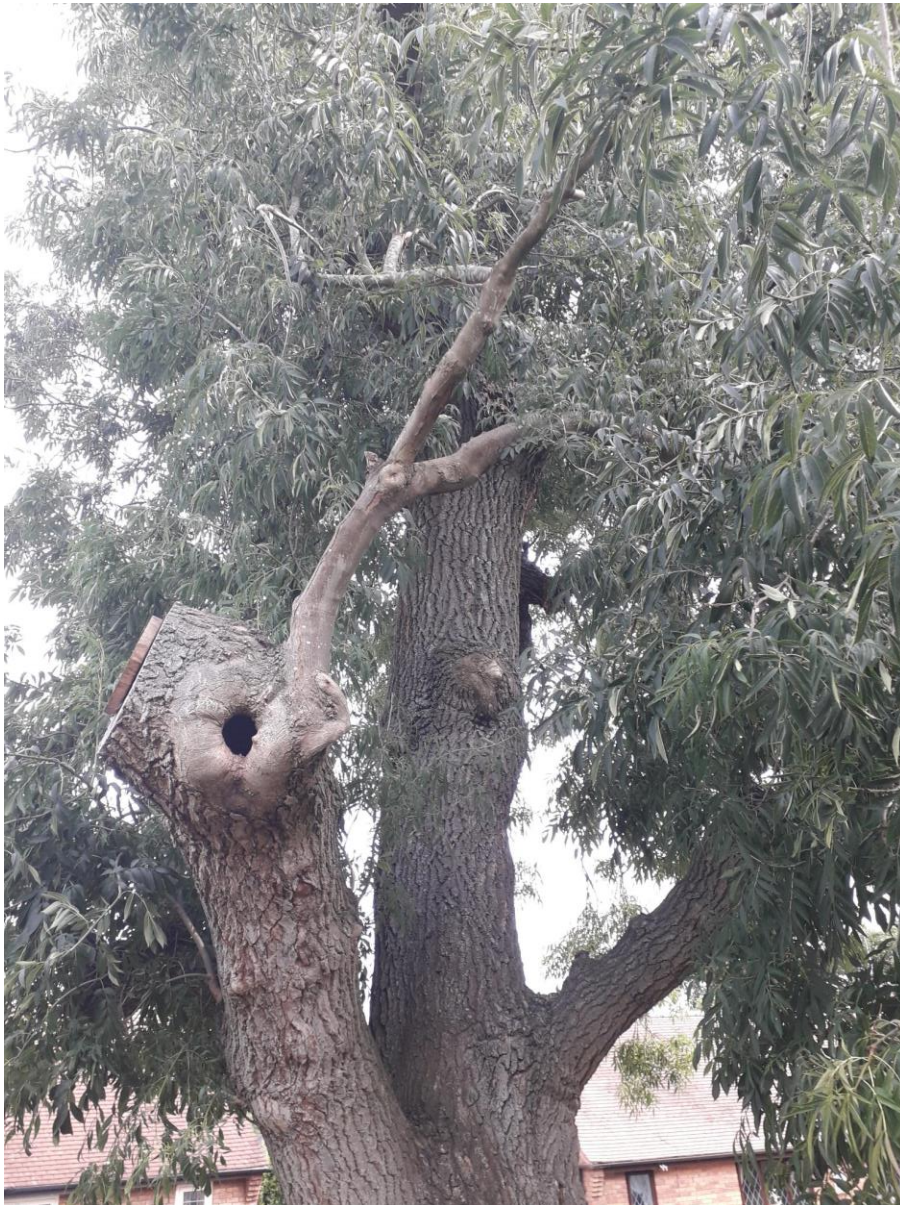
Photo 15 – disused nesting cavity.

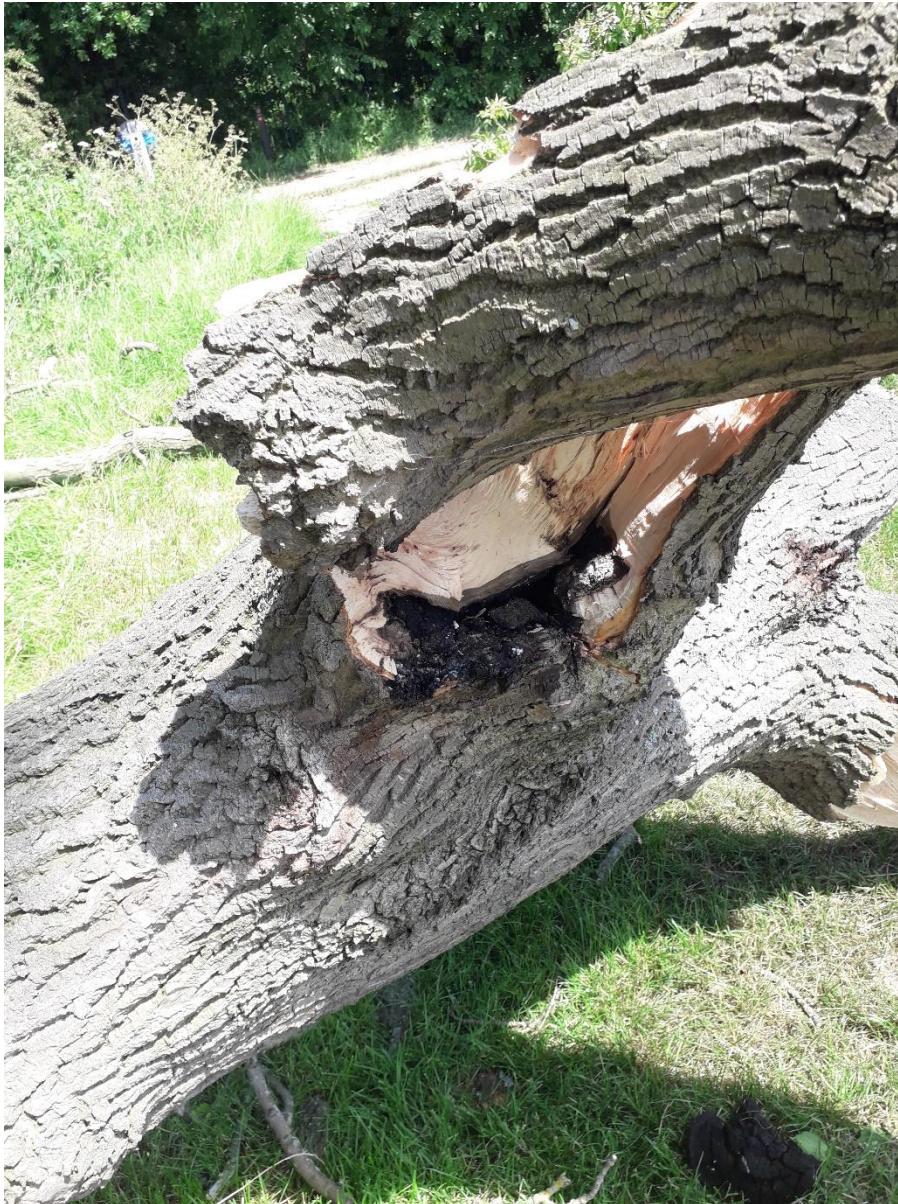
Photo 1.

Brittle failure of main fork showing a pocket of decay and degraded wood tissue.

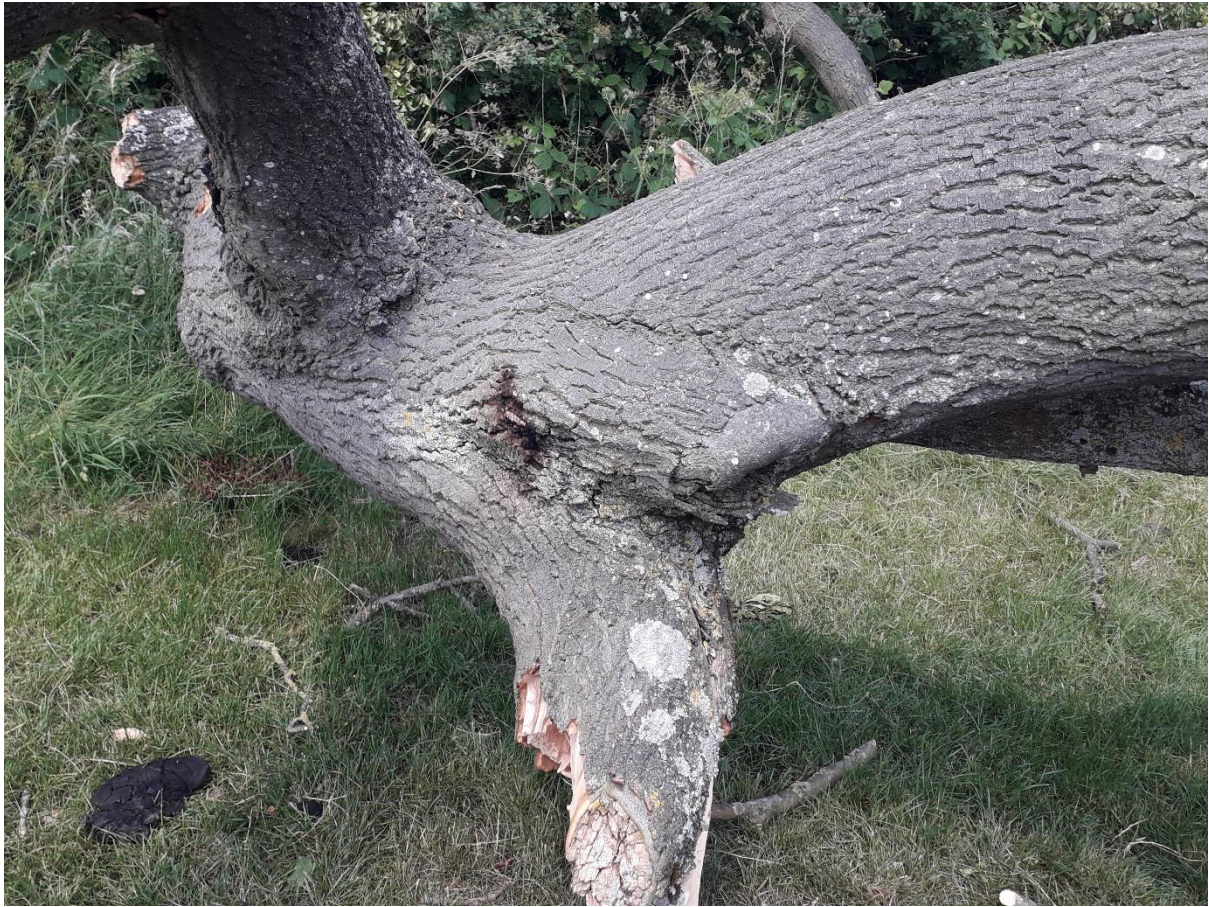
Photo 2.

Snapped limb through brittle wood tissue, with mark of fruiting body at main fork and fruiting body on grass nearby.

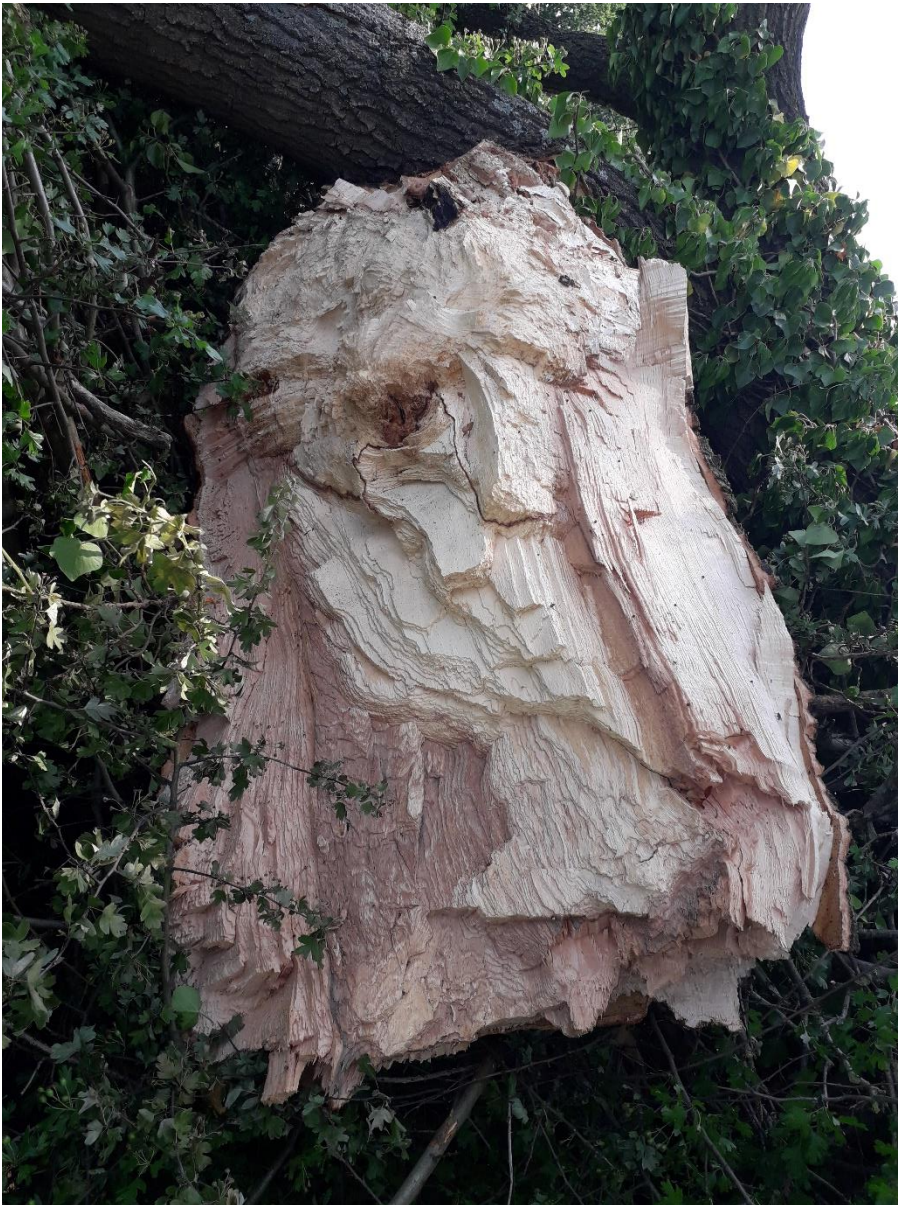
Photo 3.

Image of the end of the snapped out main limb showing the cubicle nature of cell structure through *Inonotus hispidus* degradation.

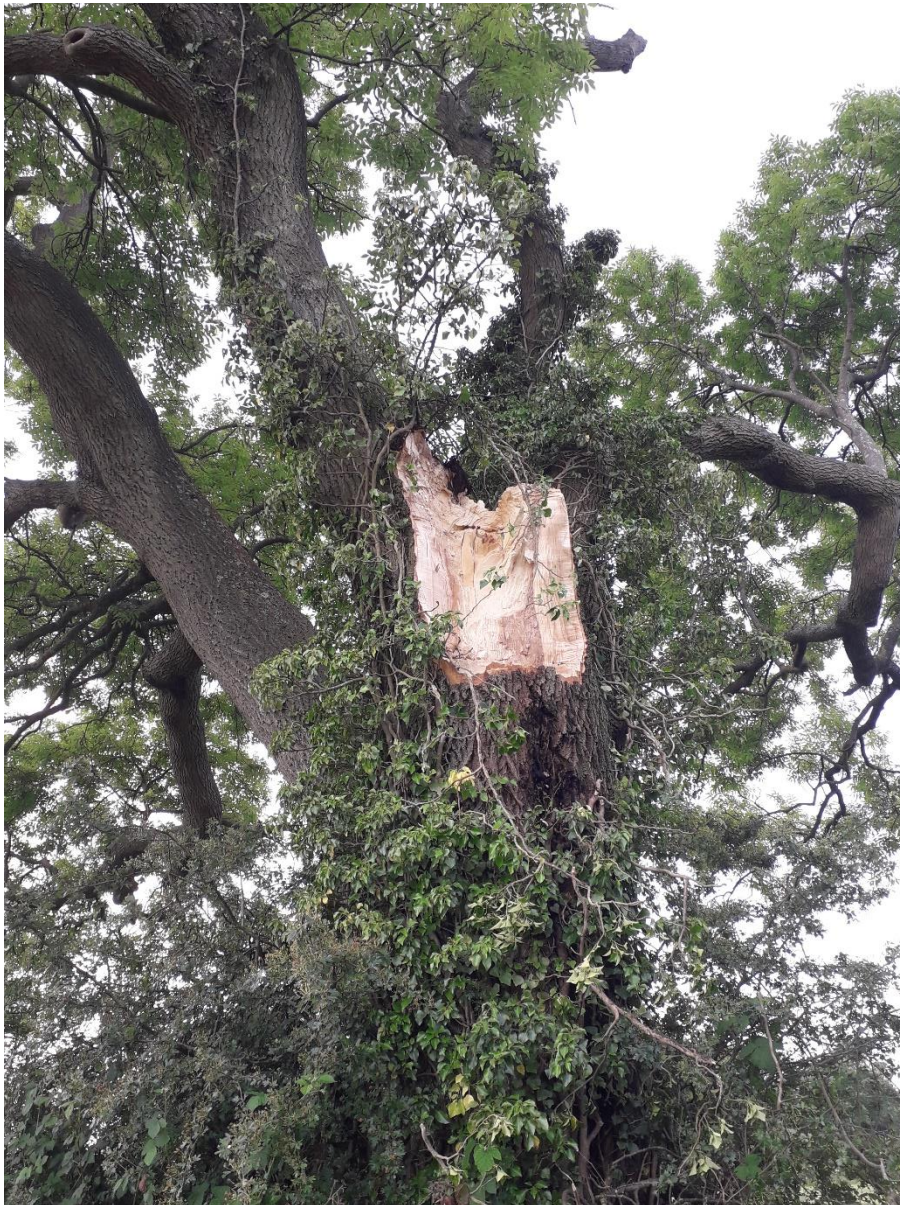
Photo 4.

Position of limb failure in tree.
