Post Installation Report
Coventry City Council
@
Tick Tock Play Area

Inspection Ref: 48123

Inspected: 09 February 2012 at 14:20 Inspector: Jon Dalton RPII Annual Inspector

Risk Assessment: **8 - Low Risk**

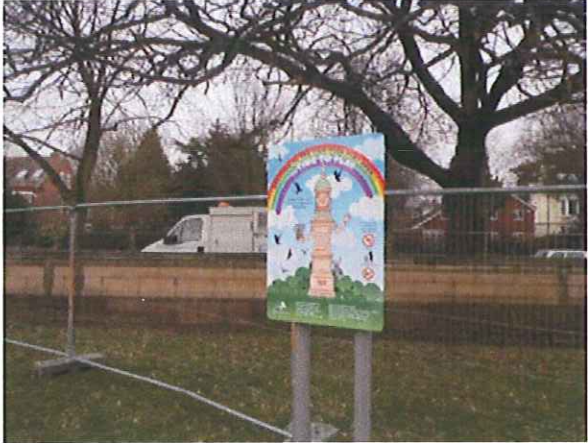
2 - Very Low Risk	
<p>Item: Ancillary Items - Sign</p> <p>Manufacturer:</p> <p>Surface Type: Please Select</p> <p>Equipment Compliance: N/A</p> <p>Surface Area Compliance: N/A</p>

Finding 1	
Suitable information signage including emergency contact details provided

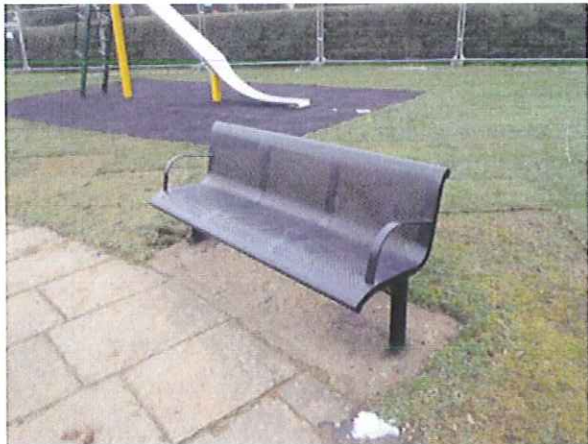
3 - Very Low Risk	
<p>Item: Ancillary Items - Bench - Steel</p> <p>Manufacturer:</p> <p>Surface Type: Please Select</p> <p>Equipment Compliance: N/A</p> <p>Surface Area Compliance: N/A</p>

Finding 1	
This item is satisfactory - no work required

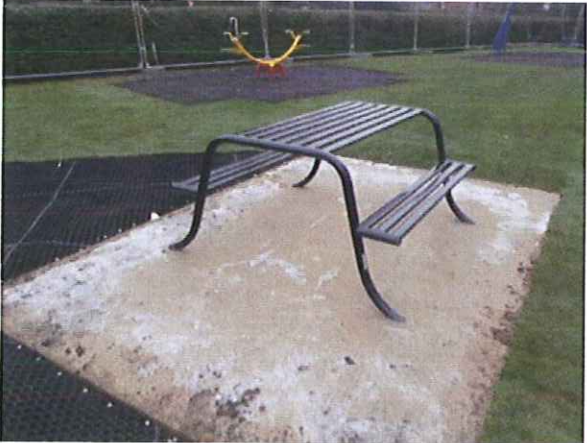
Item:	Ancillary Items - Picnic Table - Steel
Manufacturer:	
Surface Type:	Please Select
Equipment Compliance:	N/A
Surface Area Compliance:	N/A

This item is satisfactory - no work required

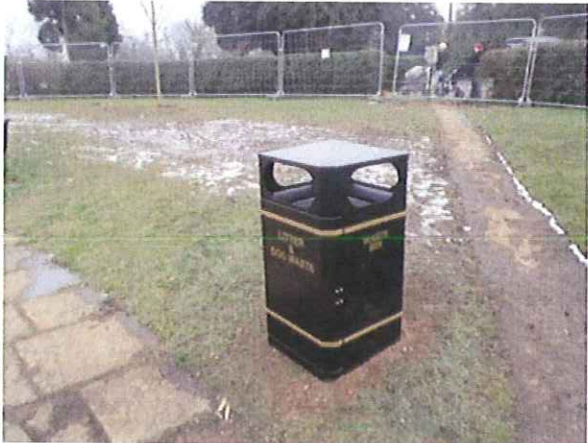
Item:	Ancillary Items - Bin - Ground Based
Manufacturer:	
Surface Type:	Please Select
Equipment Compliance:	N/A
Surface Area Compliance:	N/A

The item is loose in the ground - Reinstall item to secure.

Finding:	The item is loose in the ground		Action: Reinstall item to secure.

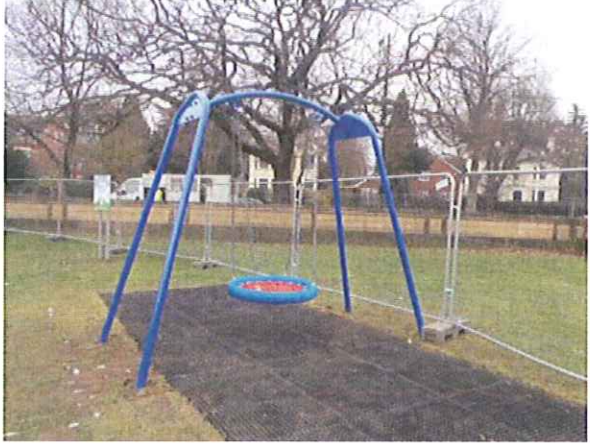
4 - Very Low Risk	
<p>Item: Swings - Basket Swing Manufacturer: Wicksteed Surface Type: Grass Matrix Tiles Equipment Compliance: Yes Surface Area Compliance: Yes</p>

Finding 1	
This item is satisfactory - no work required

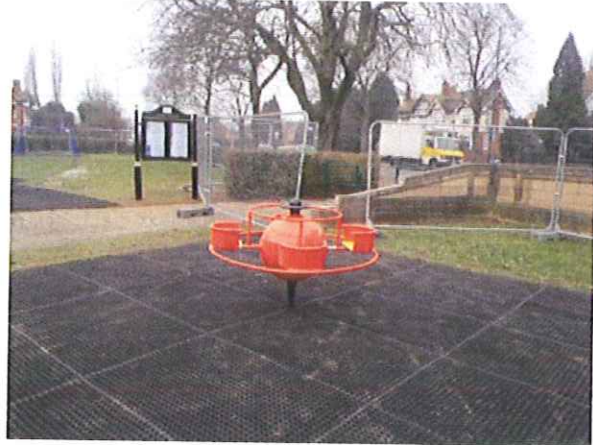
Item: Rotor Play - Roundabout
Manufacturer: Wicksteed
Surface Type: Grass Matrix Tiles
Equipment Compliance: Yes
Surface Area Compliance: Yes

This item is satisfactory - no work required

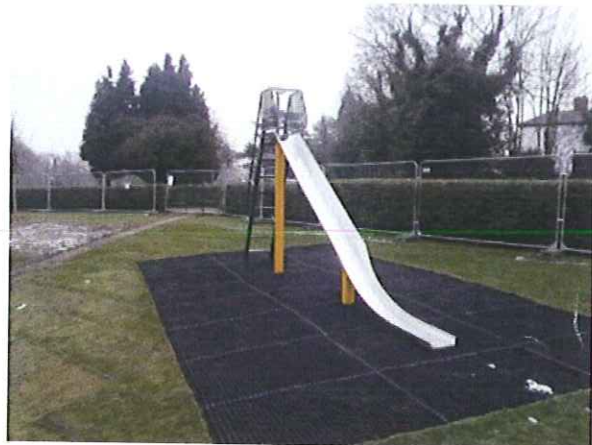
Item: Other - Free Standing Slide
Manufacturer: Wicksteed
Surface Type: Grass Matrix Tiles
Equipment Compliance: No
Surface Area Compliance: Yes

The slide has been installed slightly off centre on the fixing plate leaving a toggle entrapment - Remove toggle entrapment

Finding: The slide has been installed slightly off centre on the fixing plate leaving a toggle entrapment

Action: Remove toggle entrapment

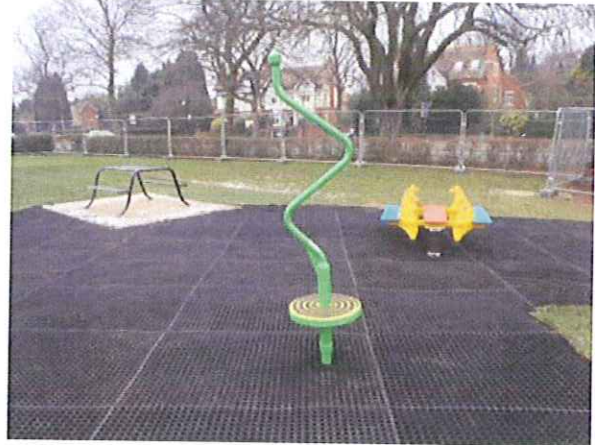
Item: Rotor Play - Zig Zag Twister
Manufacturer: Wicksteed
Surface Type: Grass Matrix Tiles
Equipment Compliance: Yes
Surface Area Compliance: Yes

The fixing is loose on the underside creating movement on the pole - Secure all loose fixings

Finding: The fixing is loose on the underside creating movement on the pole

Action: Secure all loose fixings

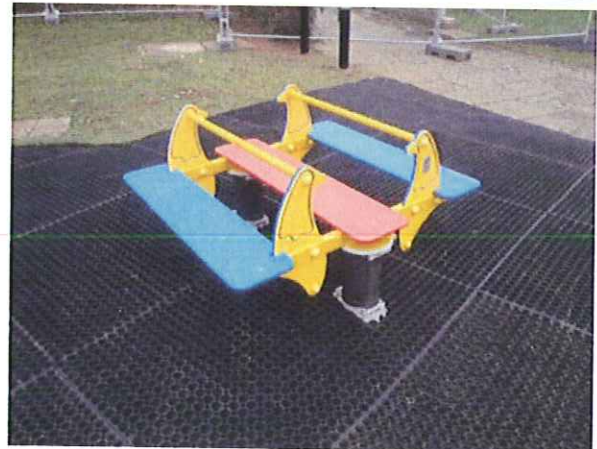
Item: Rocker - See Saw
Manufacturer: Wicksteed
Surface Type: Grass Matrix Tiles
Equipment Compliance: Yes
Surface Area Compliance: Yes

This item is satisfactory - no work required

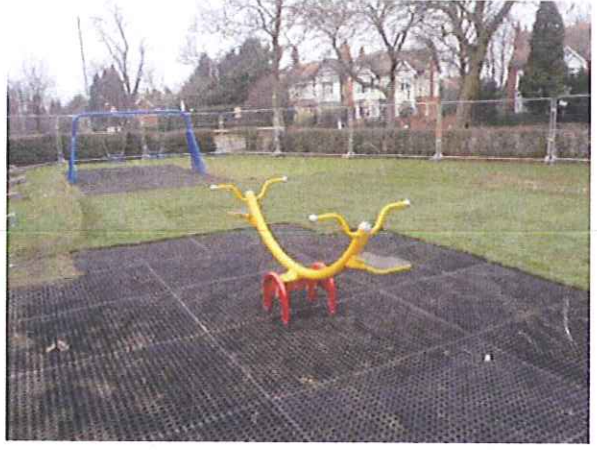
Item:	Rocker - Glow Worm See-Saw
Manufacturer:	Wicksteed
Surface Type:	Grass Matrix Tiles
Equipment Compliance:	No
Surface Area Compliance:	Yes

There is a finger entrapment between the seat and the frame; this is a low risk failure and no remedial action is recommended - Monitor Use

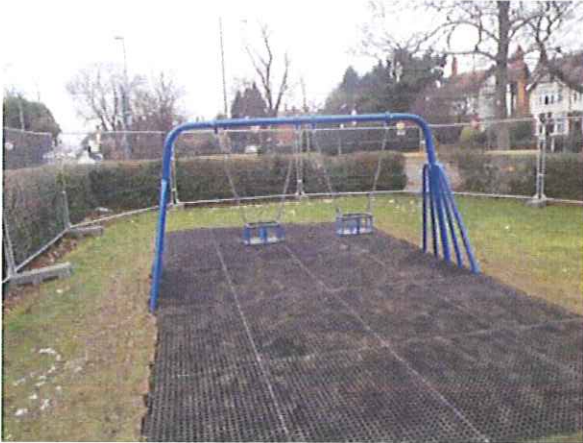
3 - Very Low Risk	
Item:	Swings - 1 Bay 2 Seat (cradle)
Manufacturer:	Wicksteed
Surface Type:	Grass Matrix Tiles
Equipment Compliance:	Yes
Surface Area Compliance:	Yes

Finding 1	
This item is satisfactory - no work required

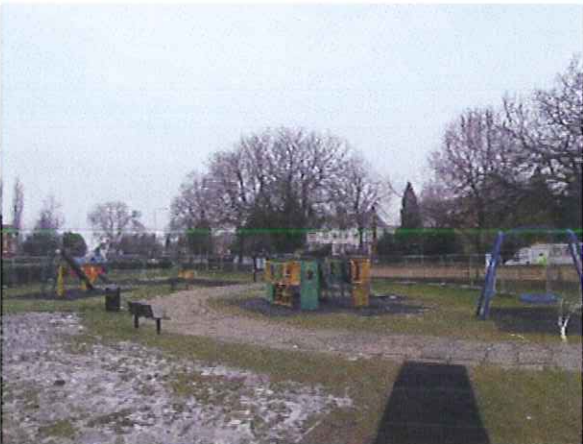
6 - Low Risk	
Item:	Ancillary Items - Site General
Manufacturer:	
Surface Type:	Please Select
Equipment Compliance:	N/A
Surface Area Compliance:	N/A

Finding 1	Finding 2
The grass edges are raised around the site creating trip points - Reinstate surrounding surface levels to remove the trip points	The grass mats are not tucked in at the edges in some places due to the ground being too hard to work with - Complete the installation to remove hazard
Finding 3	
The grass mat path leading the the area requires tucking in at the edges and the trip points removing - Complete the installation to remove hazard

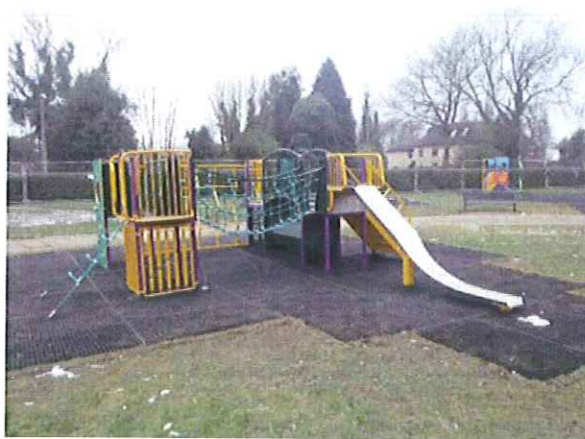
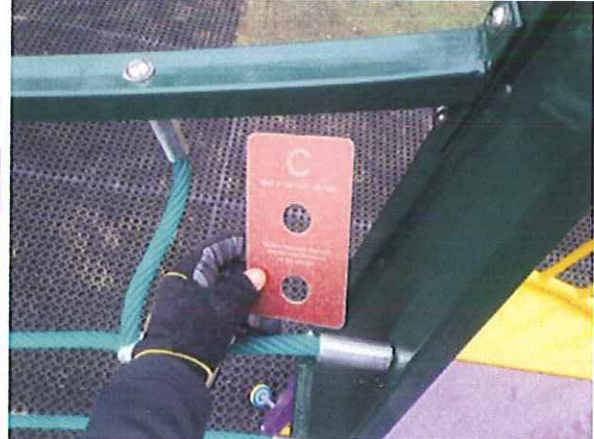
Finding: The item fails to meet the requirements for head and neck entrapment in between the net and handrail on the bridge BS EN 1176 Part 1

Action: Remove entrapments

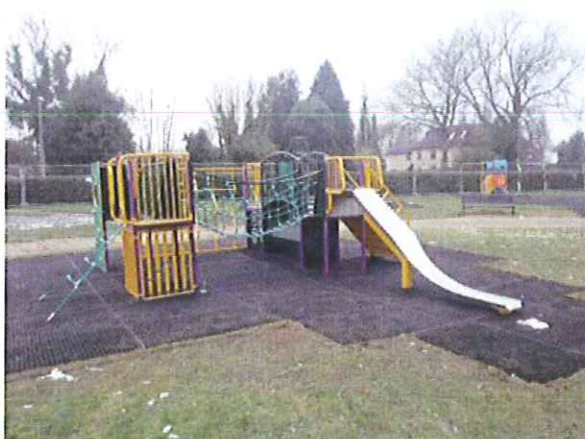
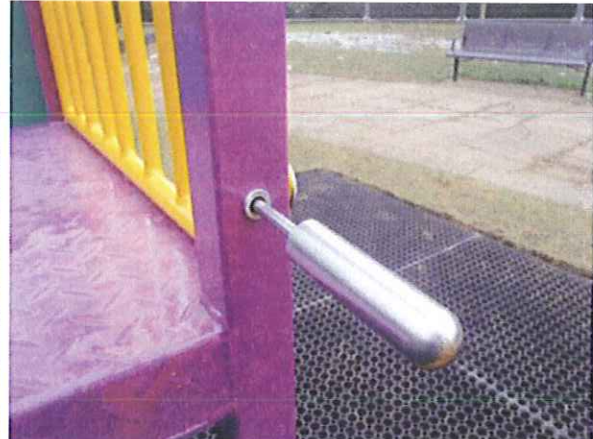
Finding: There is a missing insert resulting in a finger entrapment

Action: Provide missing insert

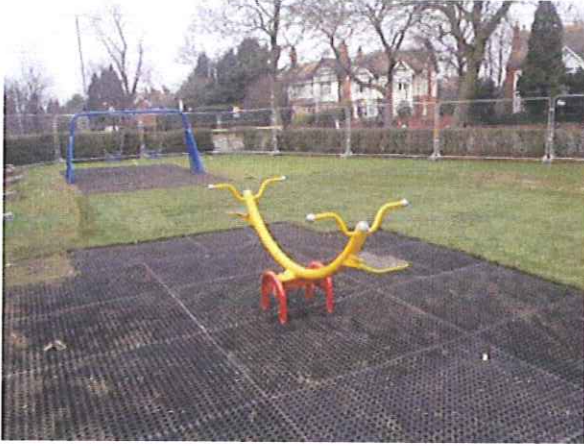
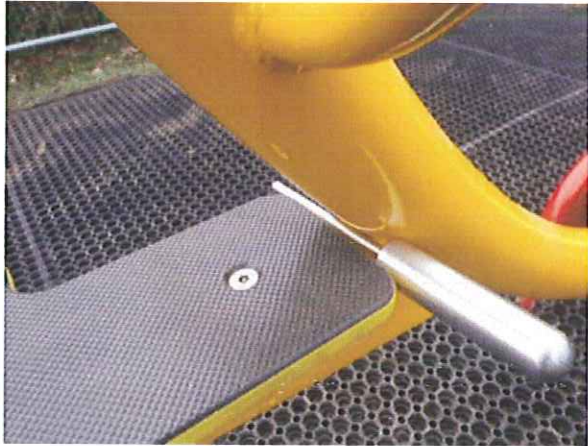
5 - Very Low Risk			
Item:	Rocker - Glow Worm See-Saw	Risk Level:	5 - Very Low Risk
Manufacturer:	Wicksteed	Surface:	Grass Matrix Tiles

Finding:	There is a finger entrapment between the seat and the frame; this is a low risk failure and no remedial action is recommended		Action: Monitor Use
