Post Installation Report
Coventry City Council
@
Tick Tock Play Area

Inspection Ref: 48123

Inspected: 09 February 2012 at 14:20 Inspector: Jon Dalton RPII Annual Inspector

Risk Assessment: **8 - Low Risk**

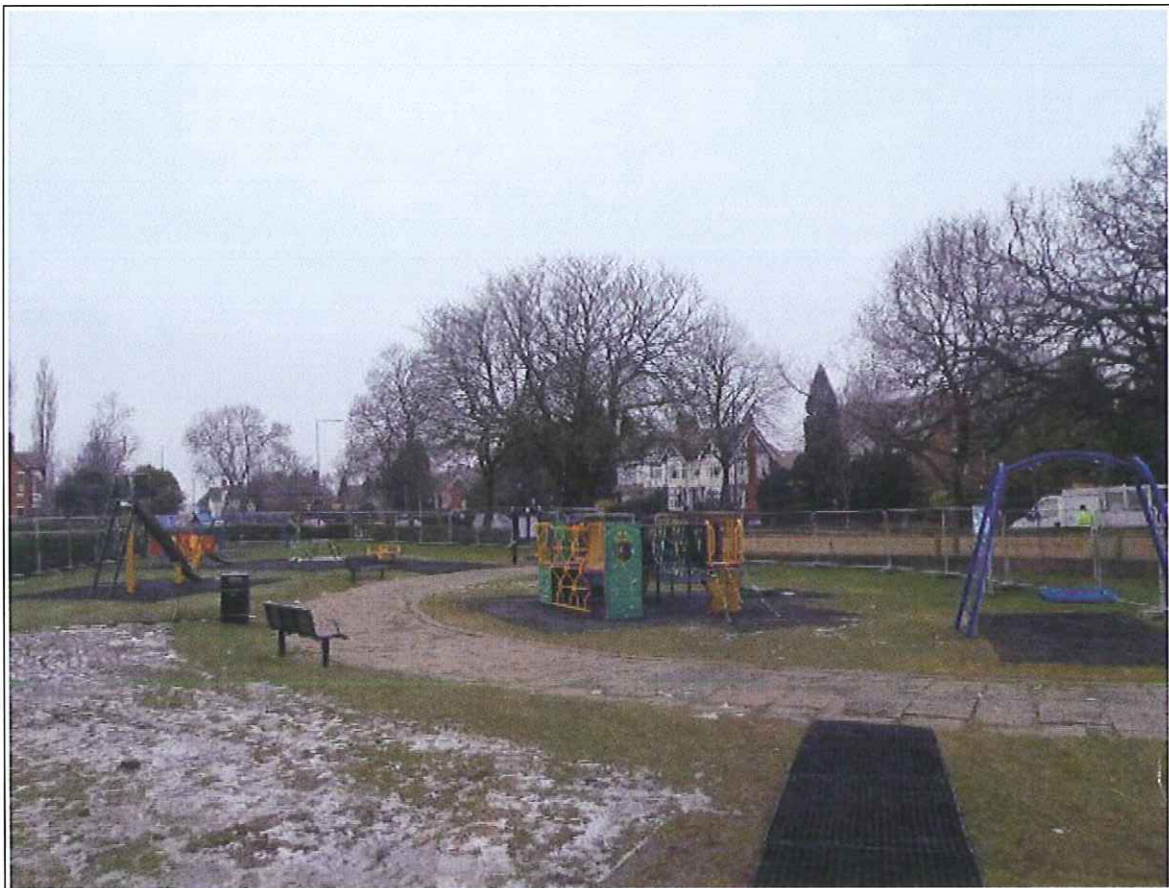
The site is located in an area of public open space and is overlooked by a number of properties in the local community.

Generally accessible – an area, accessible to most but not all people even when help is at hand.
